Manhole Inspection Summary

Manhole # S37EE_042MH

Location Address: **1112 BARCLAY ST**

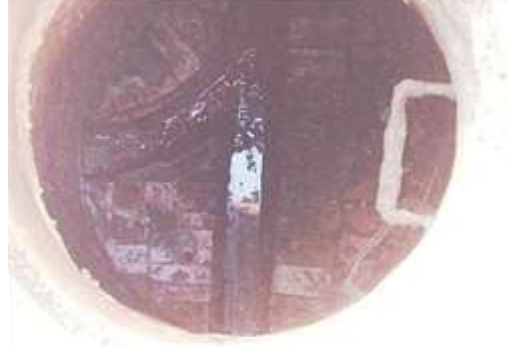
Top View

Corroded steps. Evidence of surcharge - Bench debris.

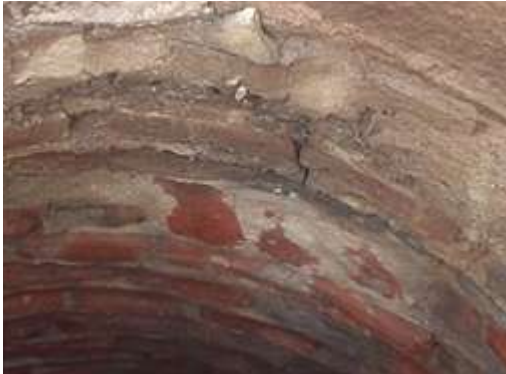
Defect

Frame leaks. Adjustment deterioration and infiltration. Corbel infiltration.

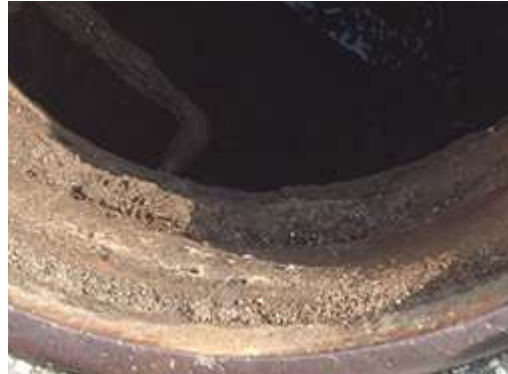
Defect

Frame offset. Frame leaks. Adjustment deterioration and infiltration.

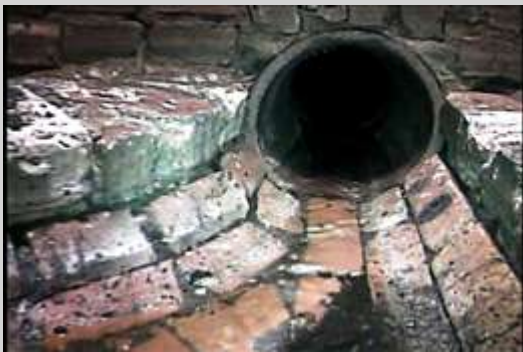
8 in. Circular Gravity Sewer Pipe Out @ 12 O'Clock

Barrel deterioration and infiltration. Channel deterioration.

Infiltration: **None** Pipe Seal Cond: **Broken**

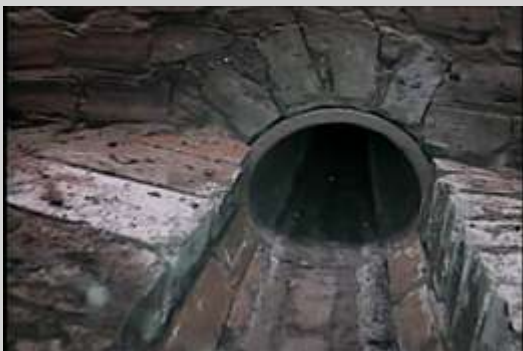
8 in. Circular Gravity Sewer Pipe In @ 6 O'Clock

Barrel deterioration and infiltration. Channel deterioration.

Deposits: ☐ None ☐ Mud ☐ Sludge ☐ Debris ☒ Grease

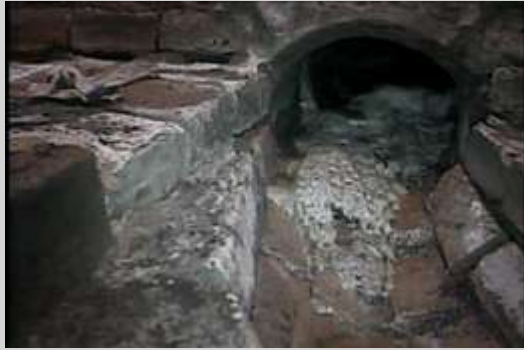
Pipe In @ 9 O'Clock

Barrel deterioration and infiltration. Bench and Channel deterioration.

Deposits: ☐ None ☐ Mud ☐ Sludge ☒ **Debris** ☒ **Grease**

Infiltration: **Evidence** Pipe Seal Cond: **Unknown**
